# REPORT

## Sanitation Concepts for Separate Treatment of Urine, Faeces and Greywater (SCST) – Results Project acronym: SCST

Anton Peter-Fröhlich (Berliner Wasserbetriebe)  
Alexandre Bonhomme (Berlin Centre of Competence for Water)  
Martin Oldenburg (Otterwasser GmbH)

2007

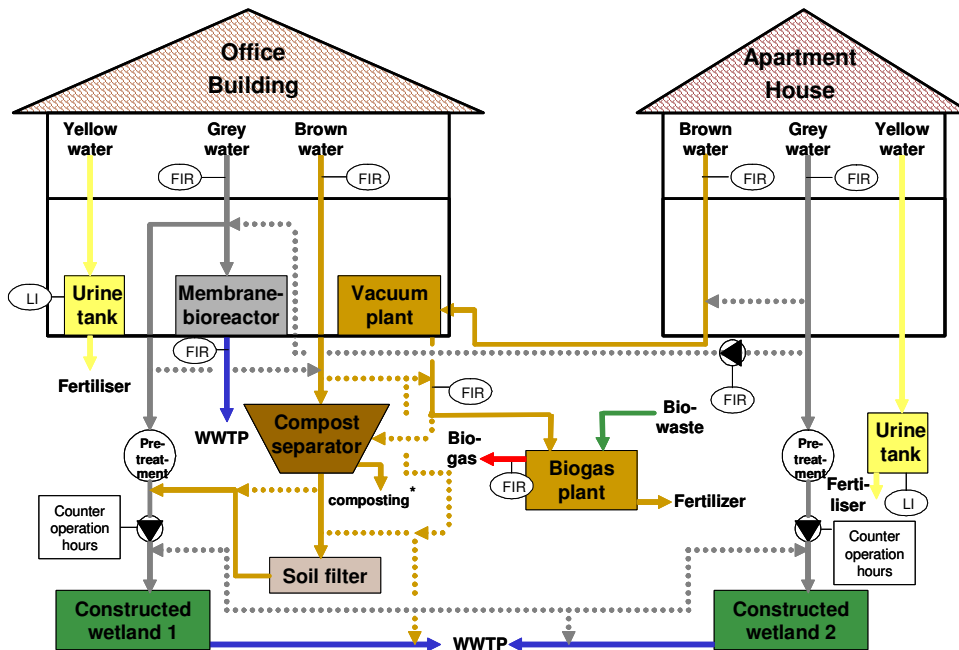
Fig. 2.1.2: New sanitation concepts with *gravity* separation toilets in the office building and *vacuum* separation toilets in the apartment house of the WWTP Stahnsdorf

These two sanitation concepts are technical options within the new approach. Other options are possible, such as e.g. composting of the faeces together with bio-waste if a production of biogas is not wanted. Similarly, the type of greywater treatment has to be adapted to local conditions. For large settlements, an activated sludge tank or a technical bio-film system etc. could be a more appropriate solution than a constructed wetland. The size of an activated sludge tank for greywater treatment, however, could be much smaller than for municipal wastewater treatment due to the much lower COD, nitrogen and suspended solids loads (Otterpohl 2001).

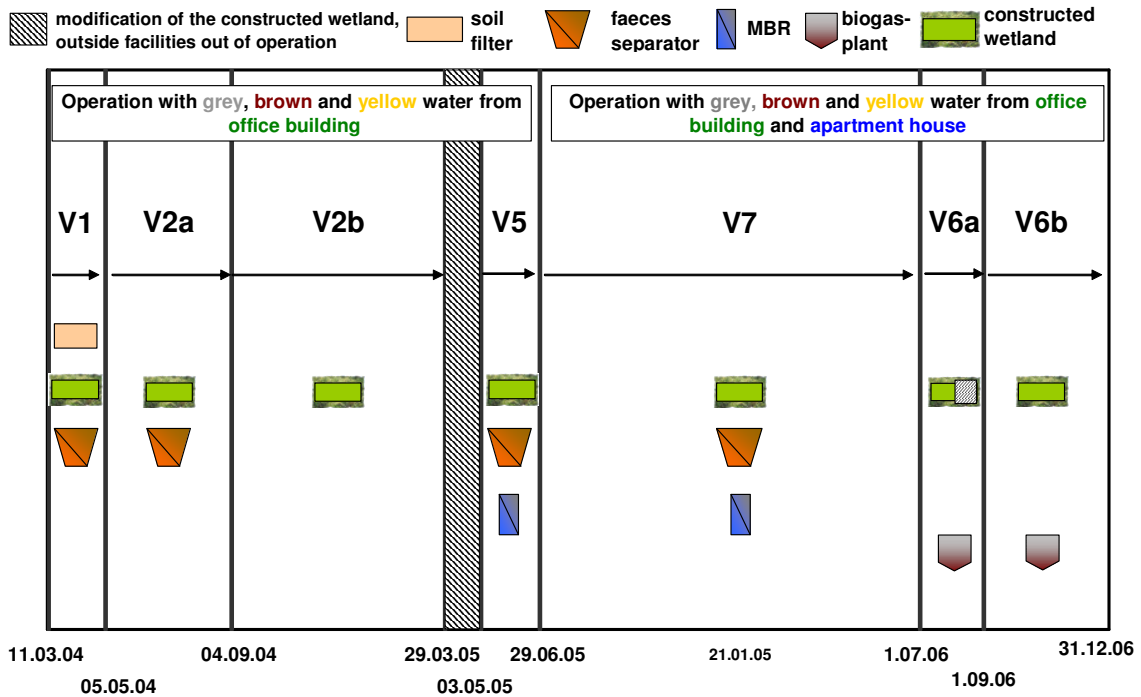
**Fig. 2.3.2:** Tested variants (V)

A general timetable of the different operation conditions is given in **Fig. 2.3.2**. Details are described below.

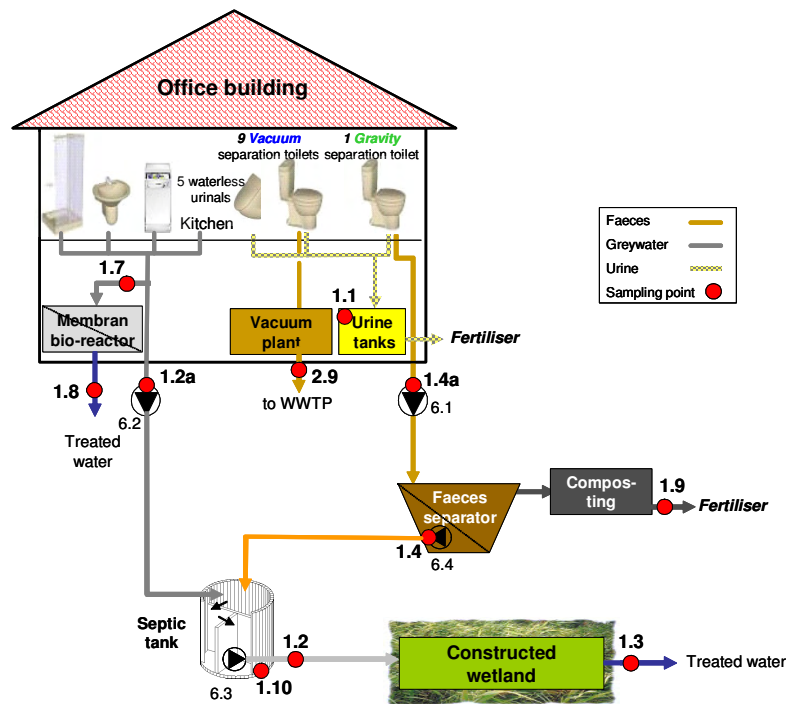
**Fig. 2.3.6:** Flow scheme of *Variant V5* (without soil filter, but treatment of faecal filtrate and operation of membrane bio-reactor)

The main research focus of this variant was to get to a stable operation process with the addition of the membrane bio-reactor and to investigate the quality of the treated greywater exclusively from the office building.

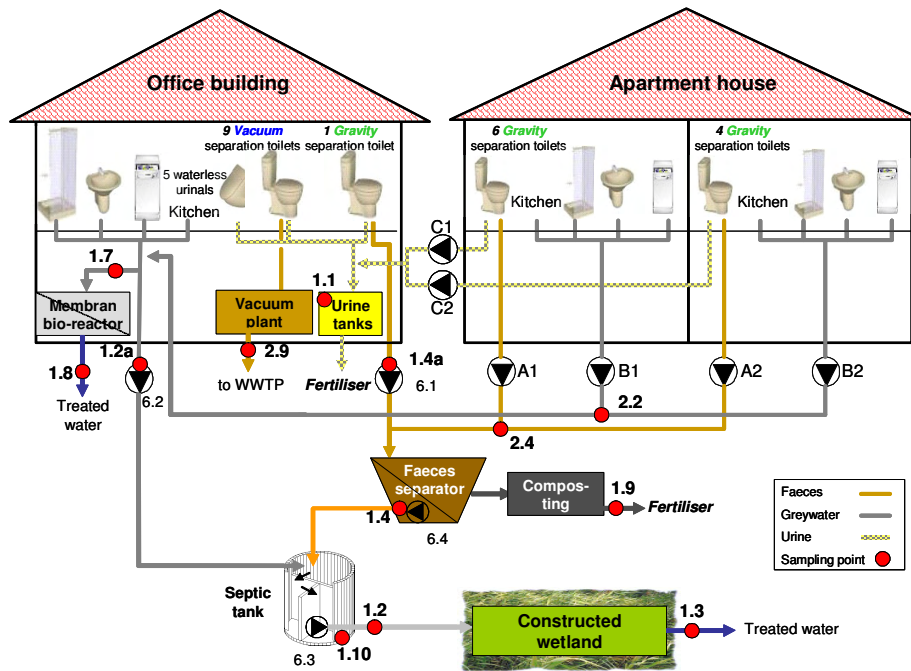
**Fig. 2.3.7:** Flow scheme of *Variant V7* (without soil filter, but treatment of faecal filtrate, operation of membrane bio-reactor including greywater from apartment house)

The main research focus of *Variant V7* was to test the effectiveness and quality of the mixture of both greywater flows.

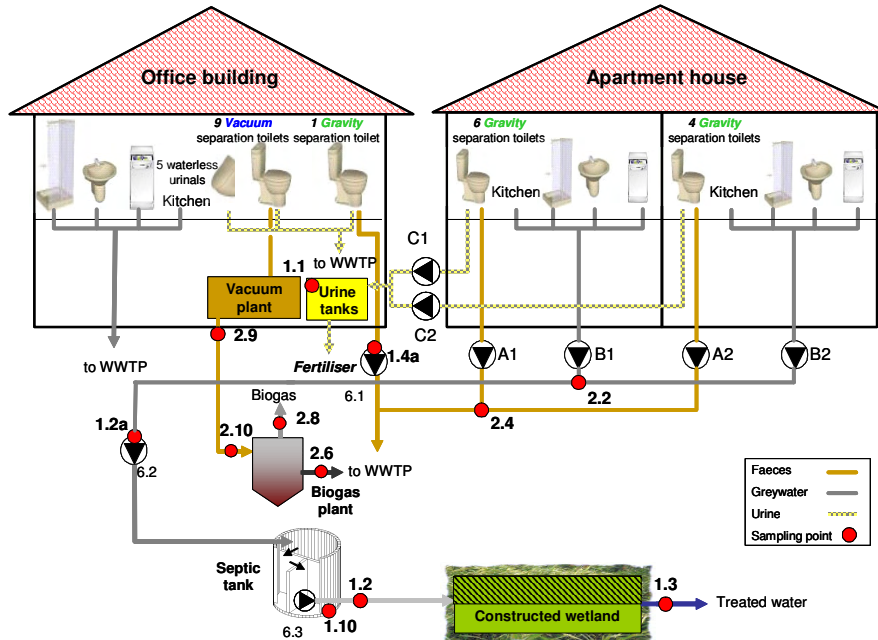
**Fig. 2.3.8:** Flow scheme of *Variant V6a* (with biogas plant, operation of the half-constructed wetland, no treatment of faecal filtrate)

During *Variant 6a*, the biogas plant could be tested for the first time (**Fig. 2.3.8**). It was operating from 1 July until 31 August 2006.

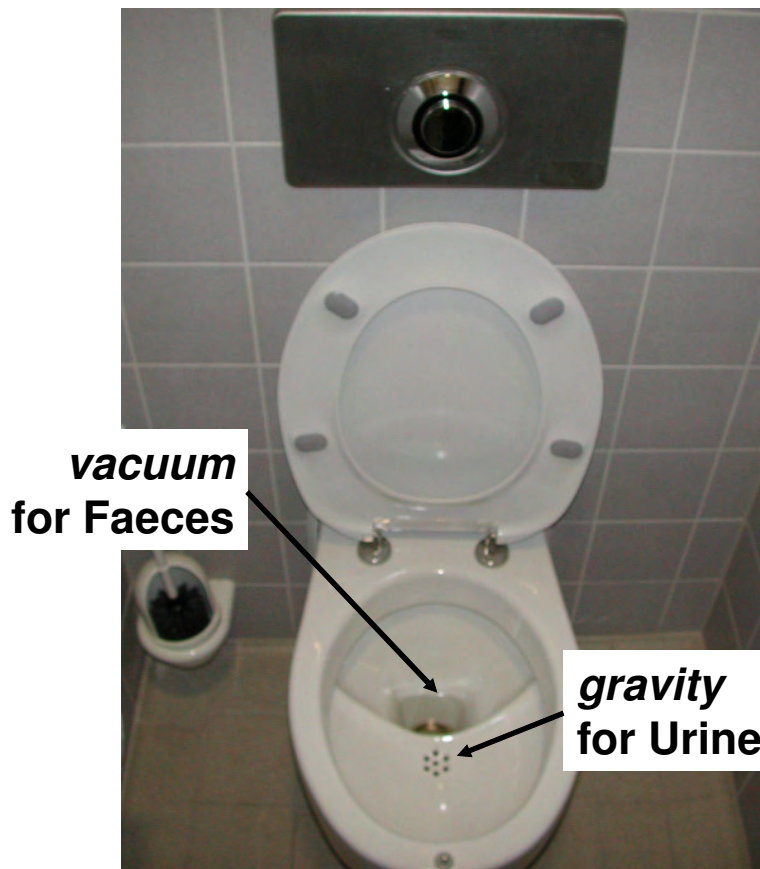
**Fig. 2.4.2:** Vacuum separation toilet

Until this day, a vacuum separation toilet is not available on the market. Therefore, the Roediger company prepared a prototype for the use in vacuum systems by modifying the gravity No Mix-Toilet. (**Fig. 2.4.2**).

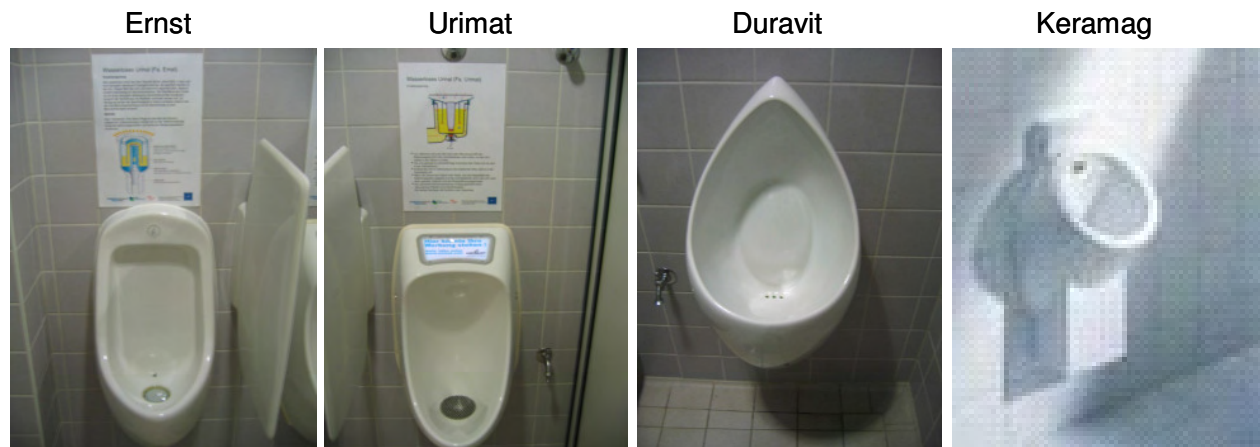
**Fig. 2.4.3:** Waterless urinals

In order to prevent odour caused by the pipe system, different systems of siphons were used. Ernst and Urimat urinals were equipped with a removable siphon. Urinals from Ernst as well as from Duravit used sealing liquids which were floating on the urine due to lower density, covering the surface. The Urimat urinals used a physical system (membrane, float, electromagnet) for the seal.

Five waterless urinals from different companies were operated in the office building: two from the Urimat company (Urimat, 2005), two from the Ernst company (Ernst 2005), and one from the Duravit company (Duravit 2005) (**Fig. 2.4.3**).

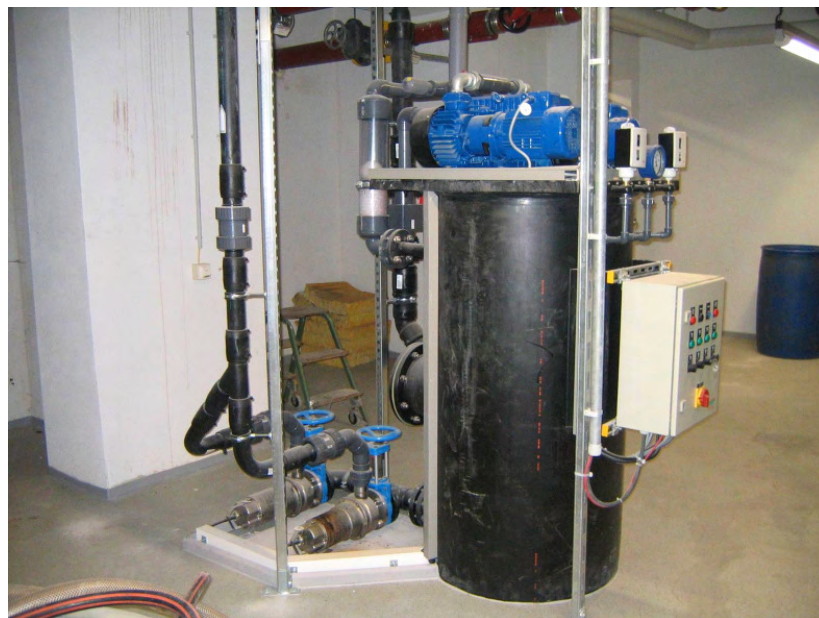
**Fig. 2.4.4:** Vacuum plant

The vacuum plant (**Fig. 2.4.4**) used in this project was the smallest unit available from the Roediger company (Roediger 2001). It was installed in the cellar of the office building and was able to serve at least 40 toilets. The vacuum (0.6 bar) was produced by two redundant vacuum pumps which were installed on top of the unit. For the discharge of brownwater from the vacuum tank two redundant pressure pumps were installed behind the small storage tank of the unit.

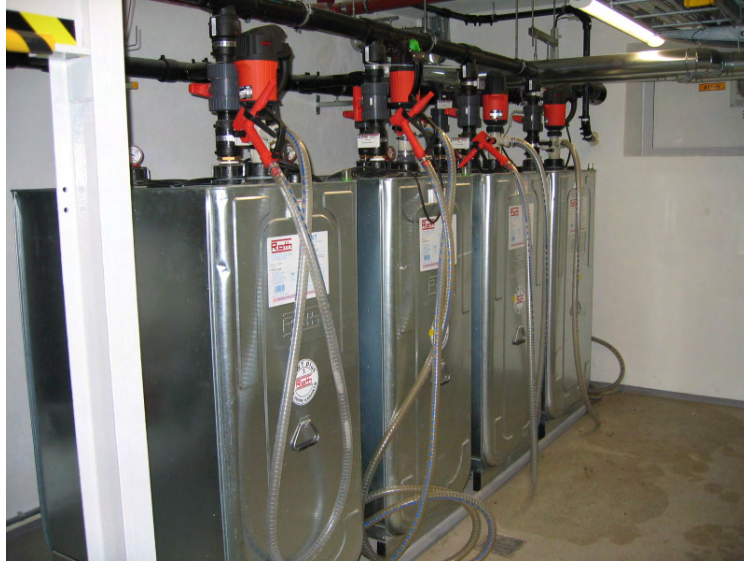
**Fig. 2.4.5:** Urine tanks

For urine storage, four tanks with double walls with a volume of 1,000 L each were installed in the cellar of the office building (**Fig. 2.4.5**). The outer tank was made of galvanised steel plate and the inner tank of polyethylene.

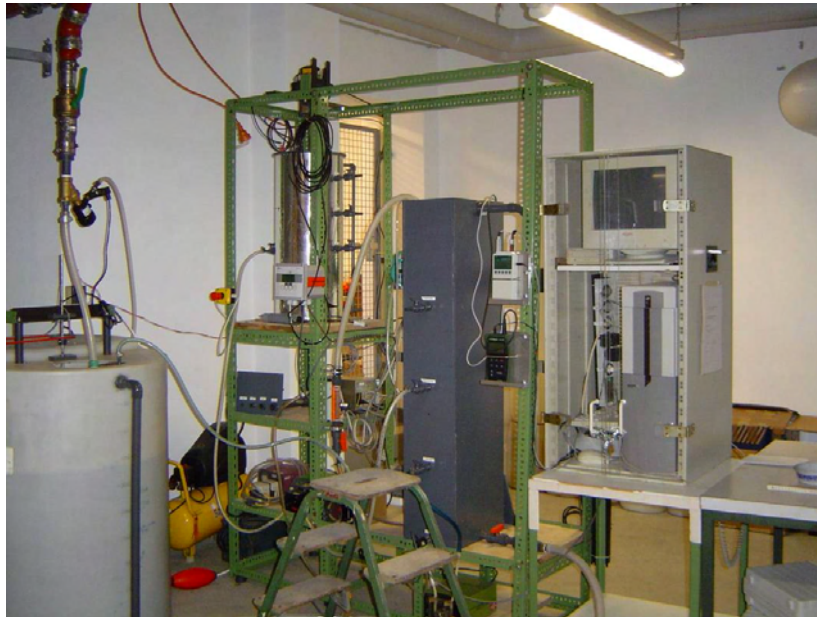
**Fig. 2.4.6:** Membrane bio-reactor

The membrane bio-reactor pilot plant (MBR) consists of a rectangular biological reactor with a working volume of 35 – 60 L. A flat sheet membrane module of 2.6 m<sup>2</sup> (polyphenol resin with 0.4 μm pore size) supplied by the company A3 water solutions (Gelsenkirchen, Germany), equipped with 2 perforated tubular aerators at the bottom of the reactor supplying air for both module scouring and the biology aeration at a constant rate of about 2.6 Nm<sup>3</sup>/h constitute the membrane bio-reactor module (**Fig. 2.4.7**). The flat sheet membranes had an orientation parallel to the filtration.

A membrane activated sludge (or membrane bioreactor, MBR) pilot unit (**Fig. 2.4.6**) was operated to treat real greywater collected from bathrooms and kitchens of the office building and the apartment house.

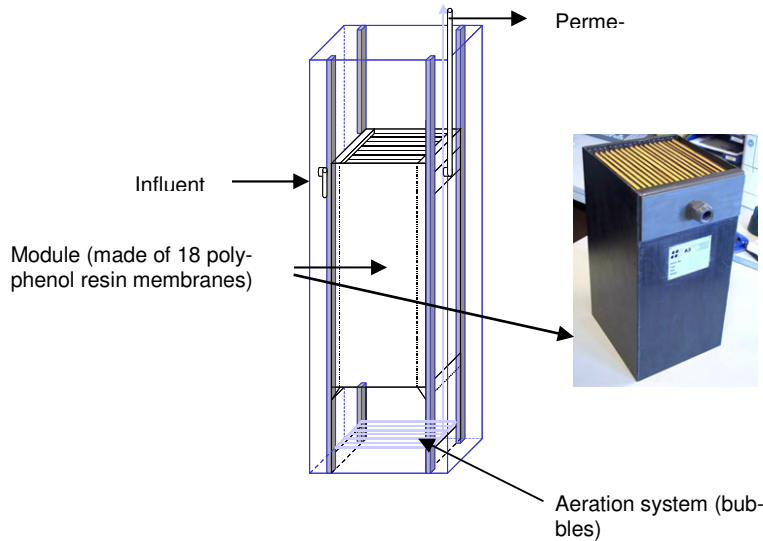
**Fig. 2.4.7:** Membrane bio-reactor module

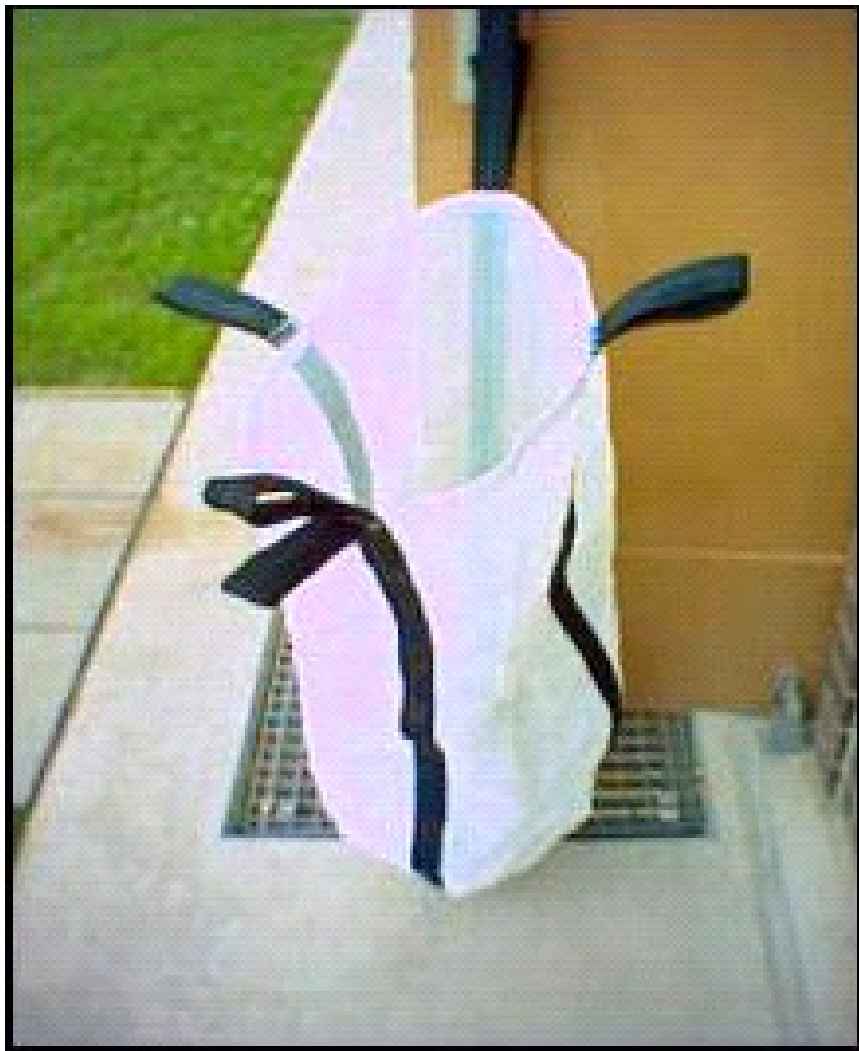
**Fig. 2.4.9:** Fugafil-Saran Filter bag (PE 1200/500) for faeces dewatering

The filter bags were from the Fugafil-Saran GmbH company (Fugafil-Saran 2005). Two different types were used: first, until 10 May 2005, the polyethylene filter bag PE 1200/500 with a pore size of 1.2 mm; then, from 11 May 2005 on, the polypropylene filter bag PP 1500/500 FLH with a pore size of 1.4 mm. Both filter bags had a diameter of 600 mm and a height of 800 mm.

The dewatering of faeces was done in filter bags (faeces separator), which are shown in **Fig. 2.4.9**.

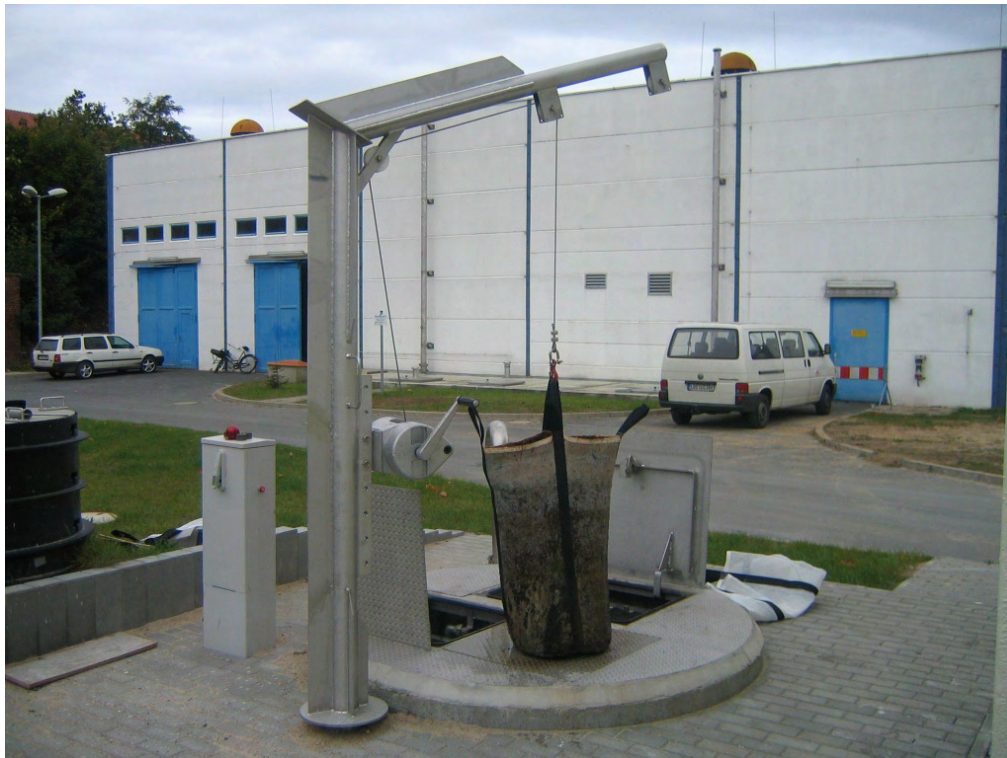
**Fig. 2.4.11:** Faeces dewatering facility including crane

By the start of the operation, about 10 litres of bark mulch were added to each empty filter bag. This improved the backing of faeces during start up of the filter bags. The filled filter bags could be removed with a crane (Fig. 2.4.11). The filtrate could be discharged into different directions with a pump as described above (see 2.3).

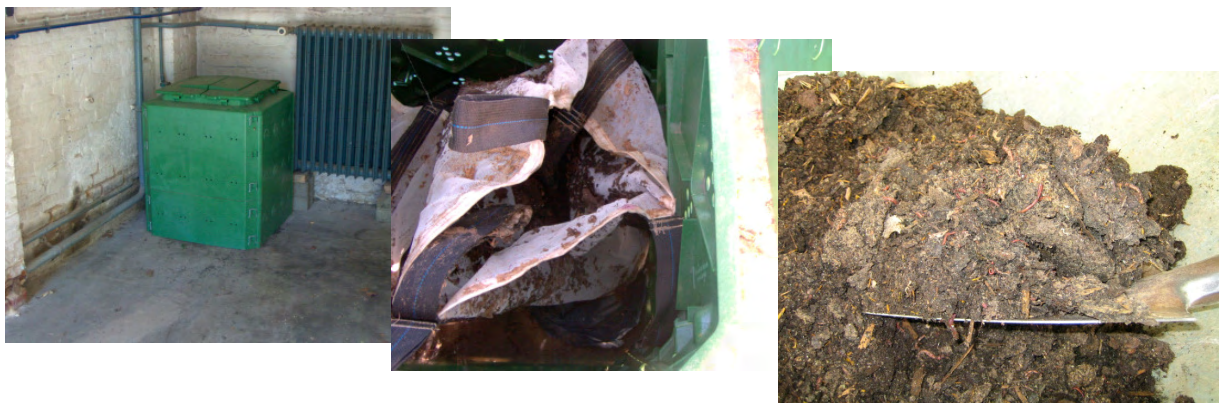
Fig. 2.4.12: Faeces for composting in a compost hood

A further collecting of faeces for composting took place from December 2005 to May 2006. These faeces originated from the toilets users of the apartment house. The thickened faeces were not composted from the Humboldt University Berlin as described above. The filter bags (four, each approx. 30 % filled) with the thickened faeces were putted in rain barrels which were not covered. The water could flow away through a bottom effluent. After adding 1,000 worms as described above the composting took place outside of a building.

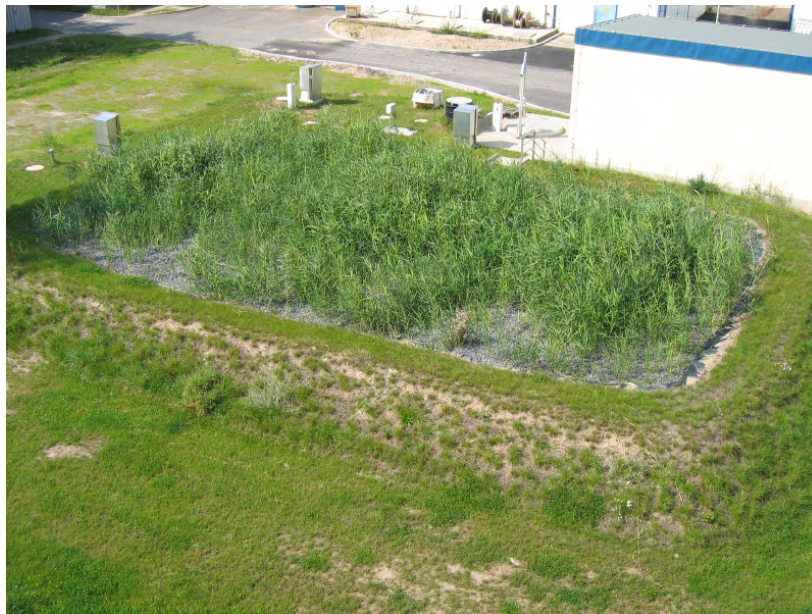
**Fig. 2.4.15:** Constructed wetland

A general view of the constructed wetland is shown in **Fig. 2.4.15**.

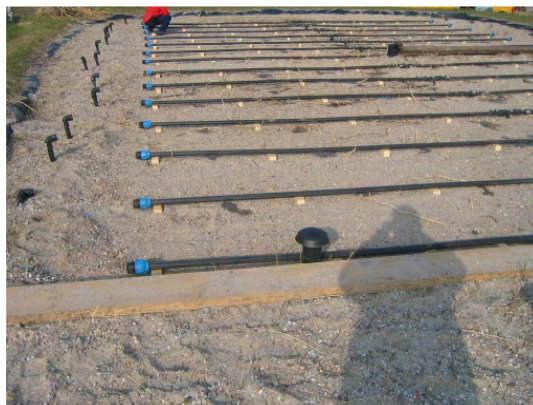
**Fig. 2.4.18:** Constructed wetland, distribution system

Based on these tests, the 8 mm holes of the distribution pipes were extended to 9 mm, and the 10 mm holes to 11 mm. Furthermore, the upper layer was replaced by another gravel layer (16/32), and the distribution pipes were covered with a 5 cm deep layer of this gravel. After these changes, the constructed wetland was replanted with reed.

After one year of operation, it became obvious that the distribution of the influent was not satisfying because the reed plants had grown to different heights and densities. Instead of a top layer with a coarse diameter of 8/16 mm (height 10 cm), the upper layer was constructed with the small coarse of 0/4 mm. Thus, the roots of the plants had grown into the distribution system by entering the holes, therefore clogging the system. Consequently, the result of the inflow distribution was not satisfying. In order to optimise the process, reed and upper layer were removed in April 2005 and tests of influent distribution undertaken (**Fig. 2.4.18**).

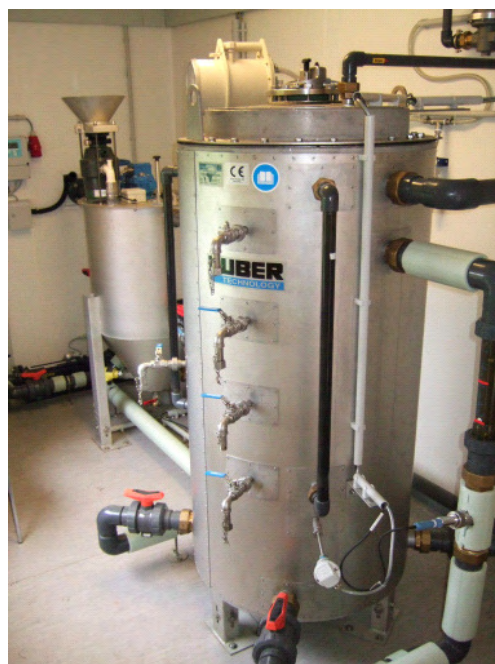
Fig. 2.4.20: Thermophile two-stage biogas plant

The biogas plant consisted of a balancing tank including stirrer (1) and the biogas-reactor itself. The first stage (2) of the biogas plant is the acidification reactor, and the second stage (3) the methanogenic reactor. In this reactor, a fixed bed made of polypropylene with a height of 600 mm and a channel size of 40 mm is installed (4) (**Fig. 2.4.21**). The sludge in the acidification stage could be mixed by means of an eccentric screw pump which sucked it from top and pumped it to the bottom into the reactor again (5). The mixture of the sludge in the methanogenic stage could be done with the same procedure, but in opposite direction (6). For the removal of surplus sludge effluent pipes with valves (7) are installed at the bottom of each stage. The biogas plant could be operated either in semi-automatic or full-automatic mode.

For digestion of the brownwater from the vacuum separation toilets and bio-waste, a two-stage thermophile biogas plant, made by the company Hans Huber AG (Hans Huber 2007), was used (Fig. 2.4.19 and Fig. 2.4.20).

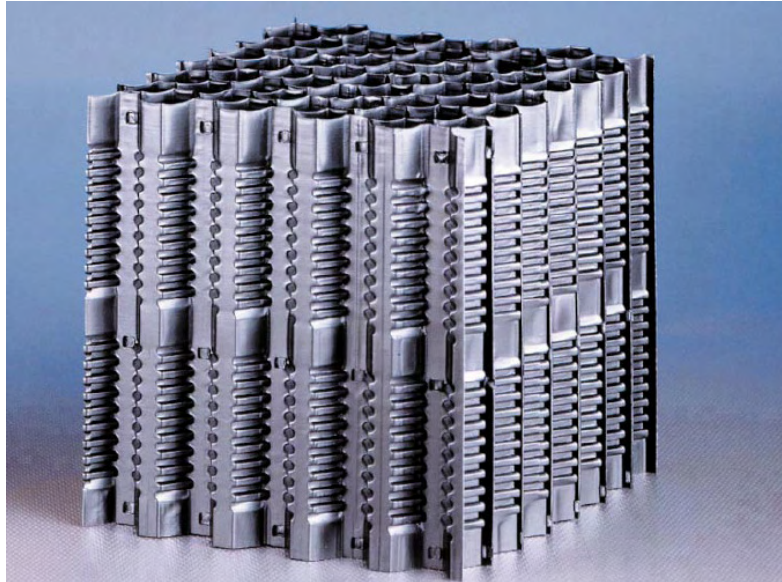
**Fig. 2.4.21:** Fixed bed (2H Kunststoff GmbH (2H Kunststoff 2007)) of the methanogenic stage of the thermopile two-stage biogas plant

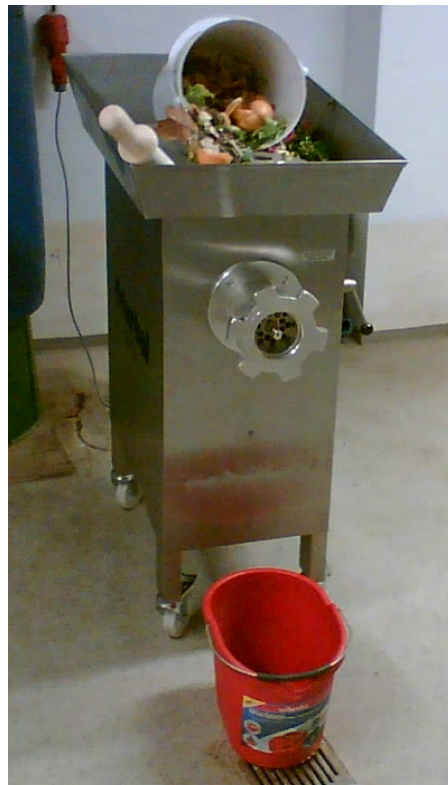
**Fig. 2.4.22:** Grinder (Edertal 2007) for bio-waste for biogas plant

For combined operation of brownwater and bio-waste from tenants of the apartment house, the bio-waste had to be grinded beforehand. This was done with a grinder from the company Edertal Elektromotoren GmbH & Co. KG (Edertal 2007).

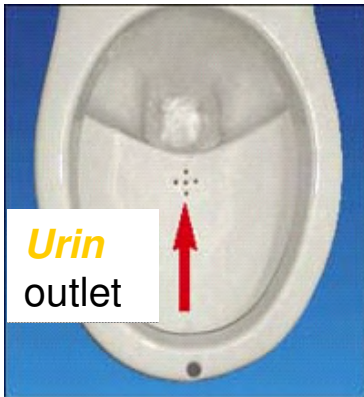
# User advice

for the new developed gravity separation toilet (Roediger *No Mix Toilet*) for separate discharge of faeces and urine (without flushing)

- Please use it only sitting down
- Please stand up before flushing

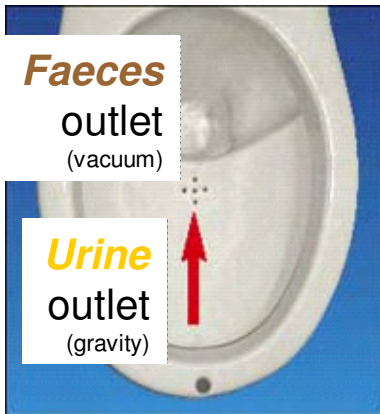
# User advice

for the prototype **vacuum** separation toilet  
(Roediger) for separate discharge of  
**faeces** and **urine**

- Please use it only sitting down
- Please stand up before flushing

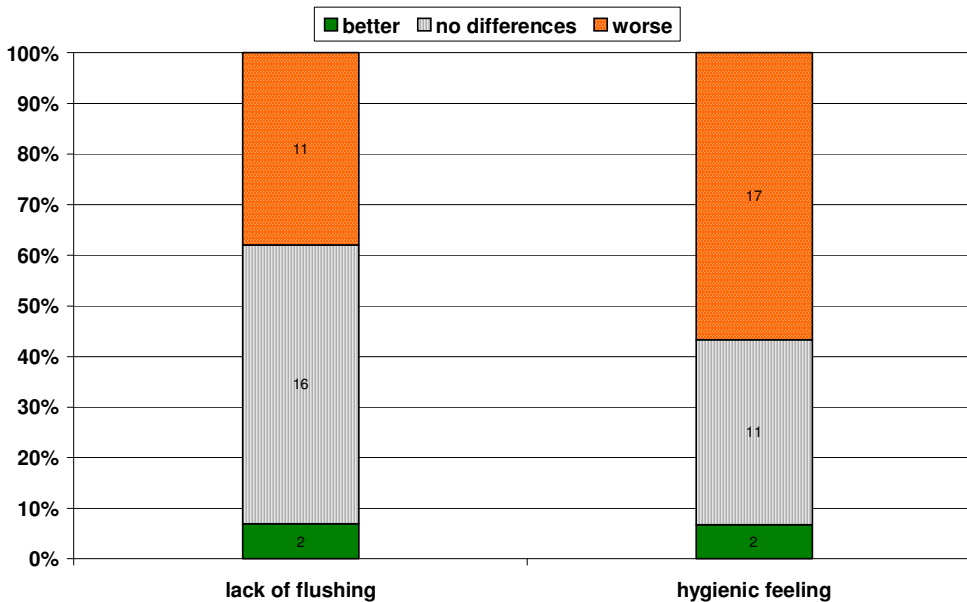
**Fig. 3.1.5:** Results of the urinal assessment

As the figure shows, approx. 62 % of the users who filled out the questionnaires did not mind the missing flush. It seems that, in principle, users accept waterless urinals. At the same time, however, approx. 57 % had a poorer hygienic feeling compared to conventional urinals. This shows that the quality of the urinals should be improved, or the awareness of the users rose through more information. The hygienic feeling could be improved, e.g. by making the urinal surface smoother to permit the urine to flow more easily to the effluent without urine drops remaining on the surface.

In order to assess the acceptance of the urinal by the male users, two questions were chosen: feeling about the missing flush and the hygienic feeling (question 8, **Fig. 3.1.1**). Since only a few of the 24 questionnaires concerning the used type of urinal were answered, the results do not allow to differentiate between the three urinals. It seems that the users did not recognise the different types of urinals. The answers to the above mentioned questions are shown in **Fig. 3.1.5**.

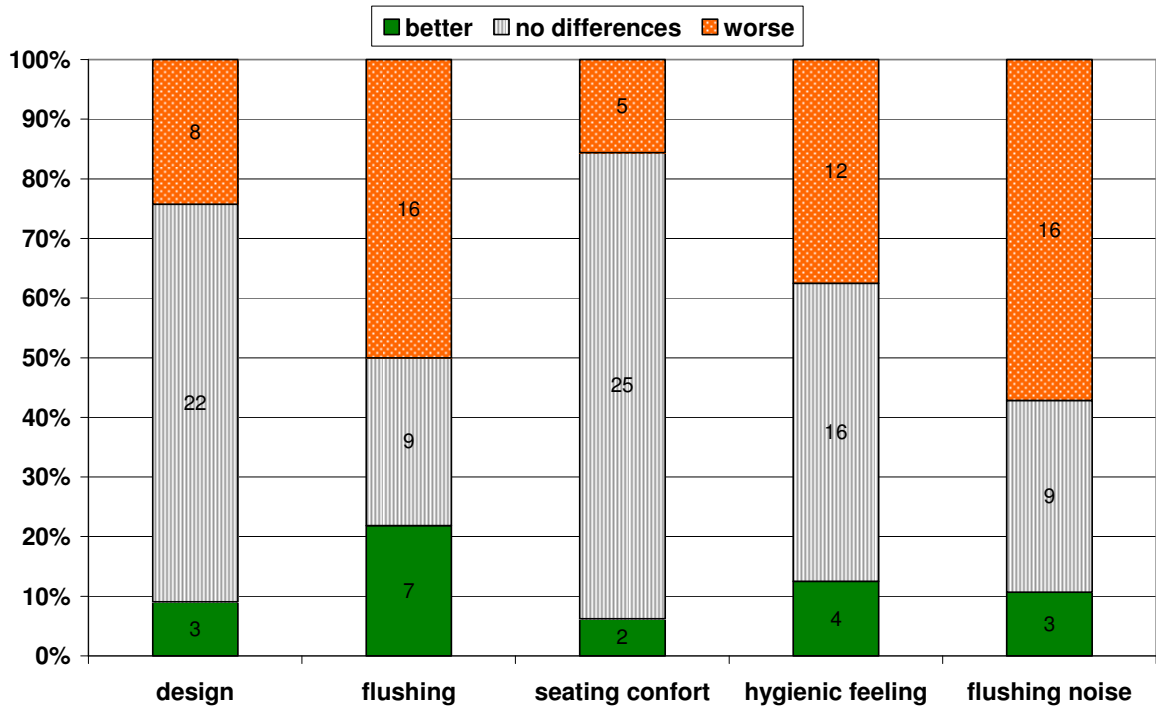
**Fig. 3.1.7:** Results of the vacuum separation toilet assessment

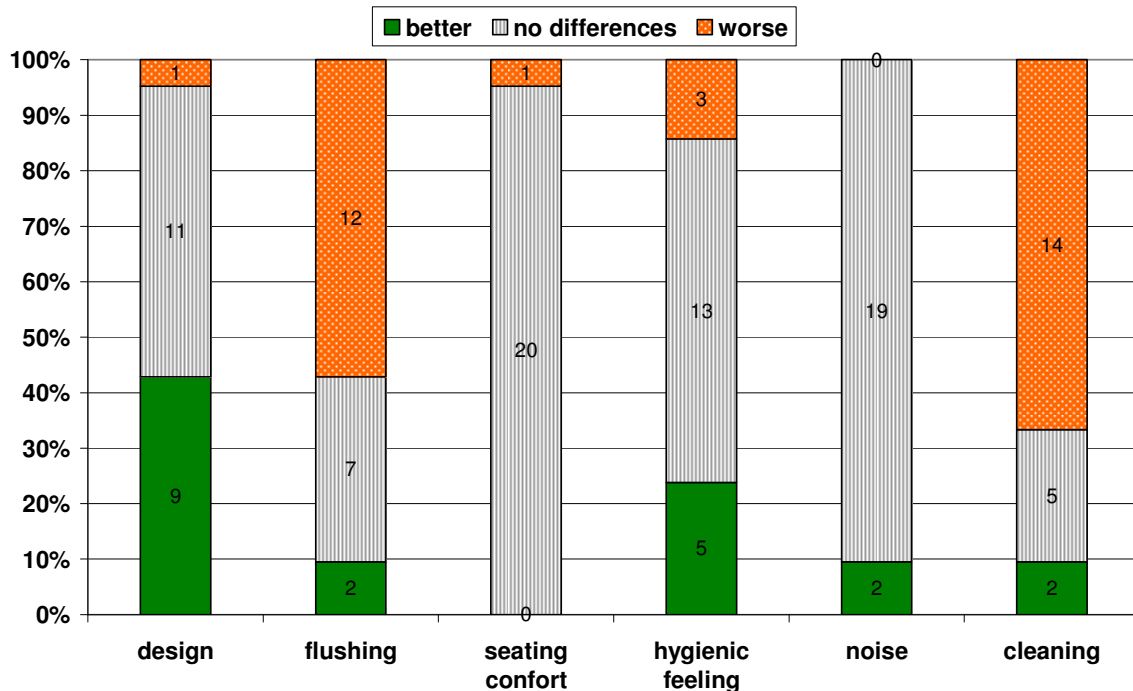
**Fig. 3.1.11:** Results of the gravity separation toilet in the apartment house

The second group of data underlines the weaknesses of the separation toilets. With regard to the question concerning the toilet flushing, 57 % of the users considered the flushing of the separation toilet to be worse than that of a conventional one. This dissatisfaction is stronger than the one observed in the office building (42 %). The non-effective flushing obliged the users to flush several times every time they used the toilet - as shown in **Table 3.1.2**. Similarly, the cleaning of the toilet appears to have been problematic. A vast majority, namely 67 % of the apartment house habitants, declared that the separation toilets were more difficult to clean than the normal toilets. The users complained about the surface area of the toilet, where yellowish marks, which were difficult to get rid of, would appear.

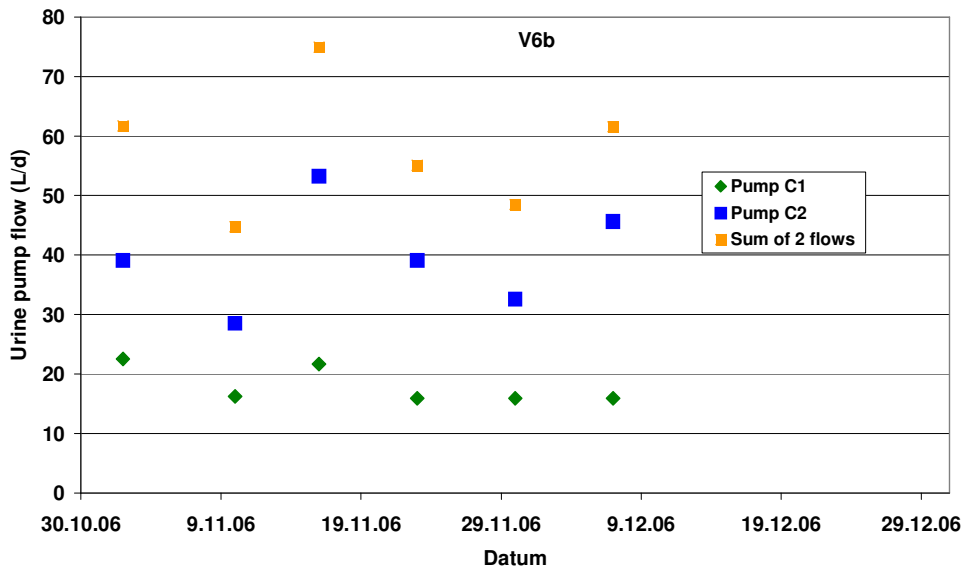
**Fig. 3.4.2:** Daily flow of urine from the apartment house

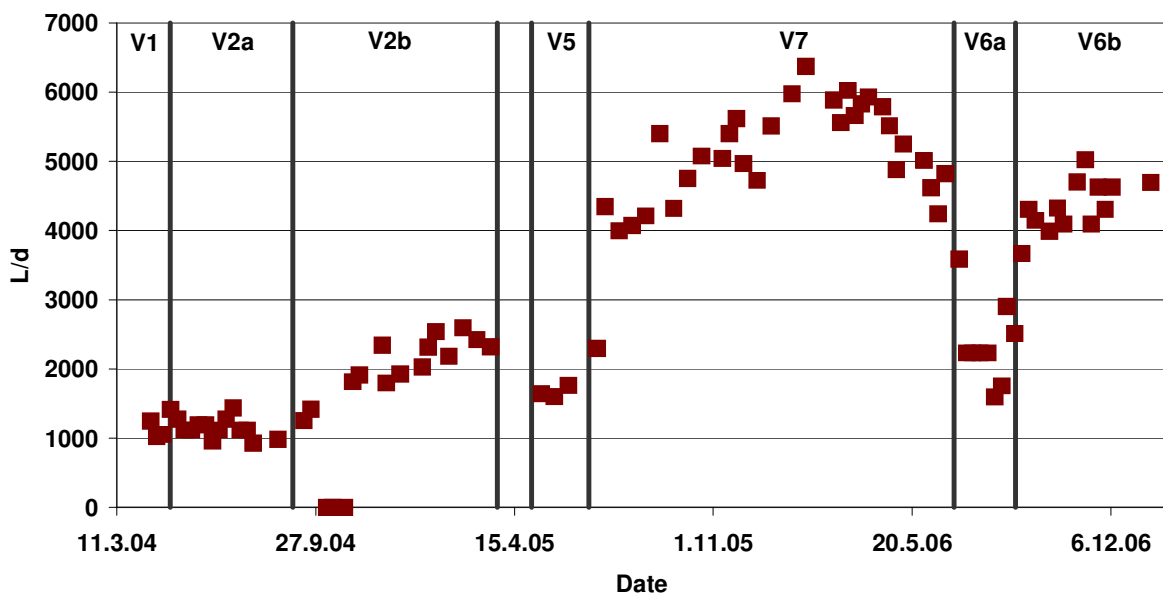
**Fig. 3.5.5.1:** Influent flow of septic tank

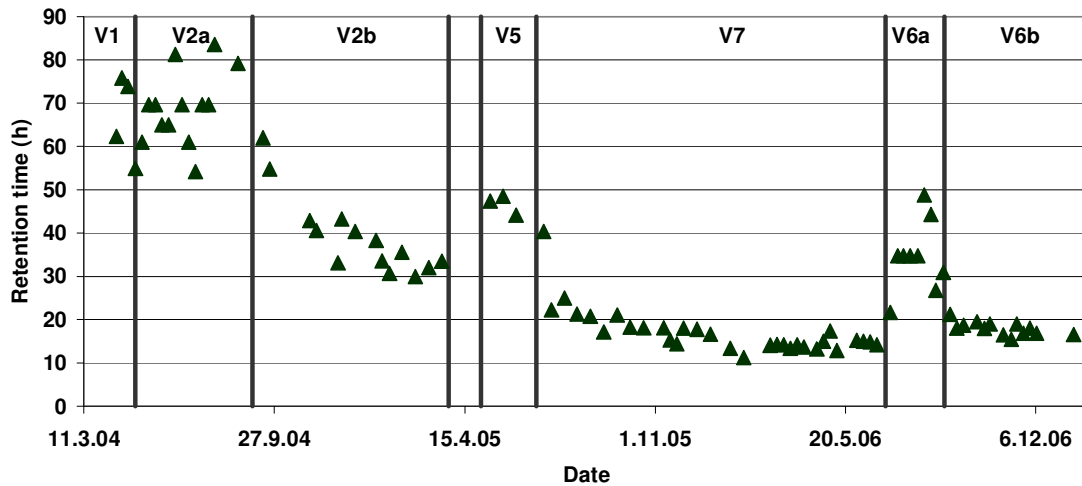
**Fig. 3.5.5.2:** Retention time of the flow in the septic tank

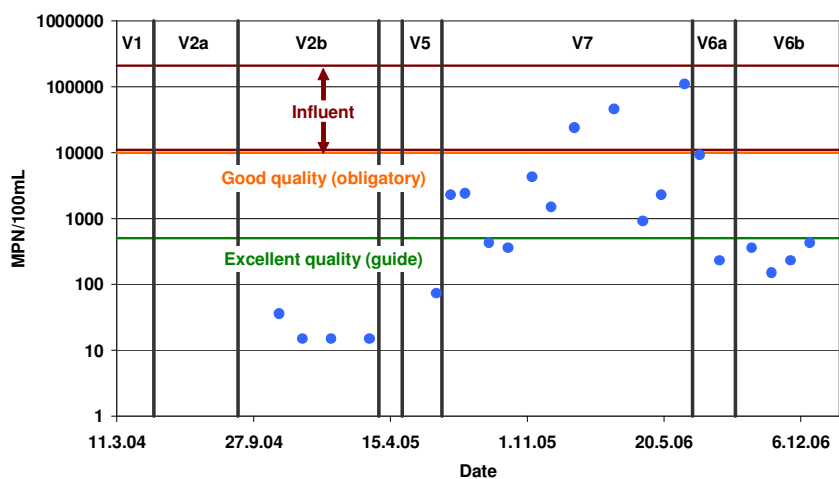
**Fig. 3.5.6.7:** Total coliforms in the influent and effluent of the constructed wetland

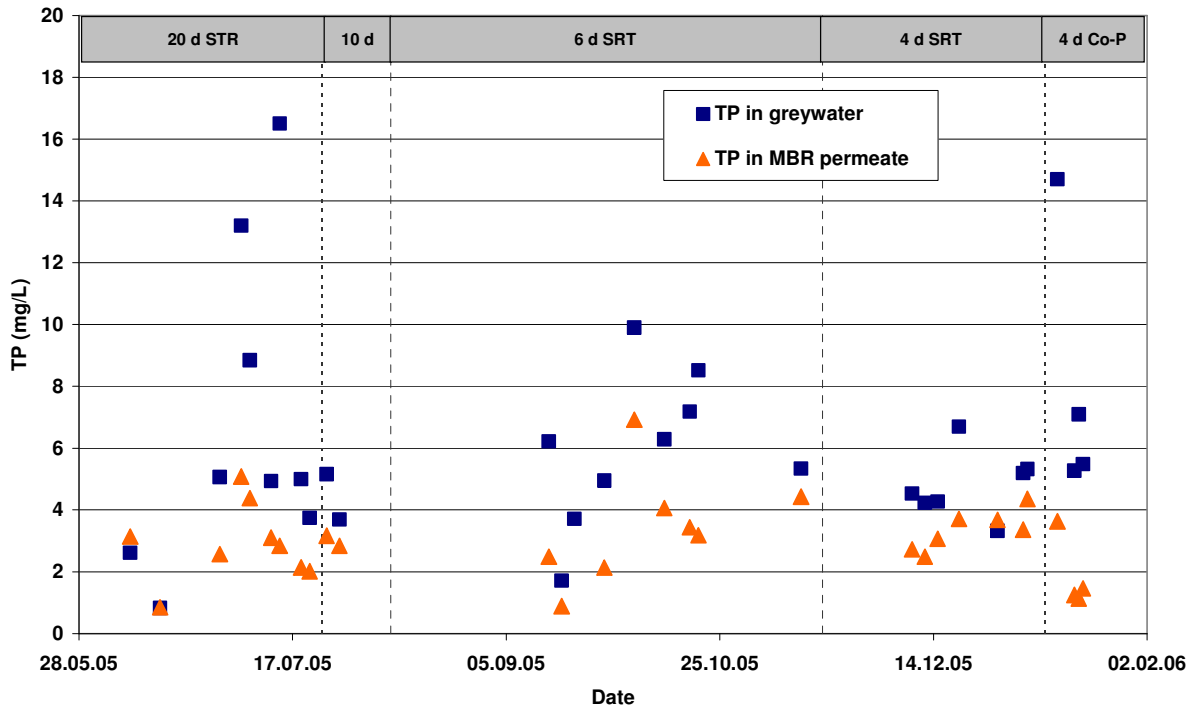
Fig 3.5.7.5: TP concentrations in greywater and in MBR permeate

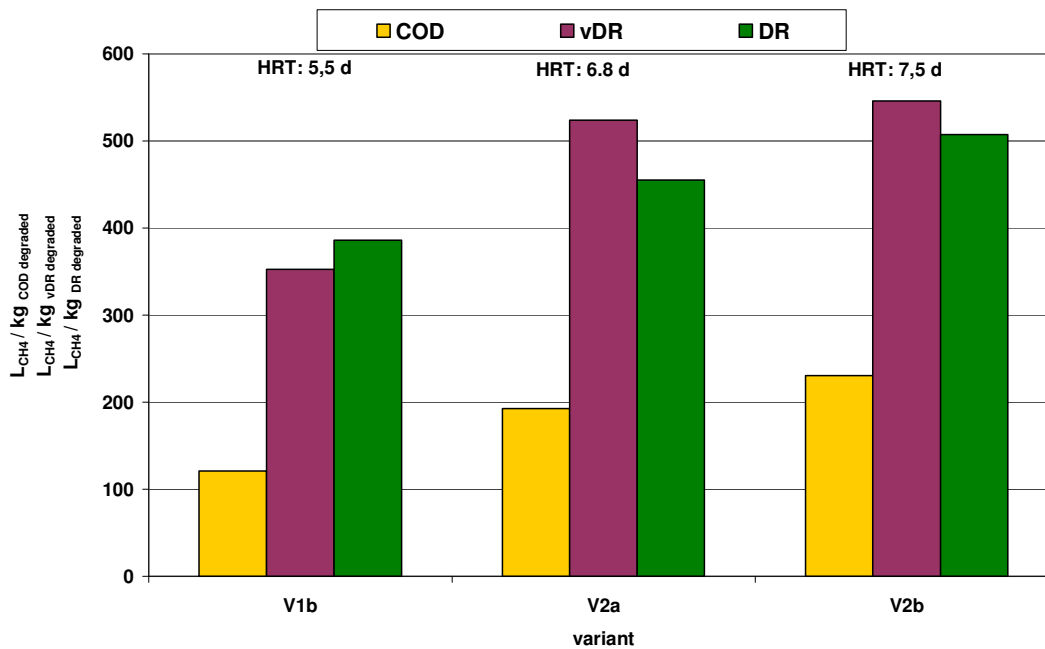
**Fig. 3.5.8.2:** Specific  $\text{CH}_4$  production (mean values) from *Variant V1b*, *V2a* and *V2b* in relation to COD, vDR and DR degraded

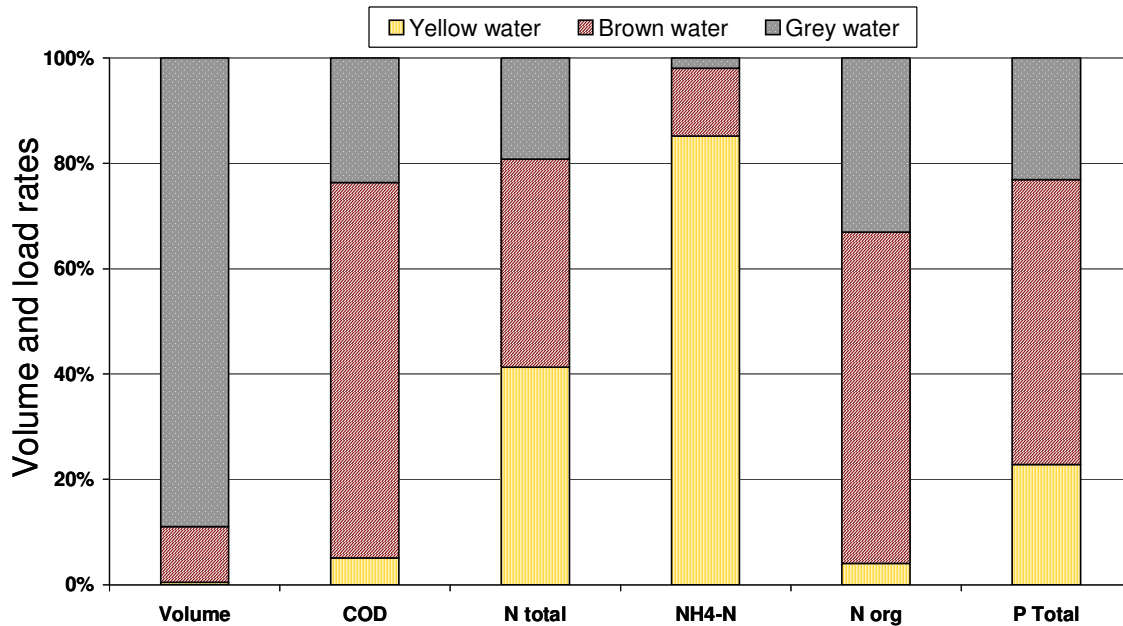
**Fig. 3.6.1:** Volume and mass balances of different parameters of yellow-, brown- and greywater from the office building (data basis: yellowwater: *Variant V1 to V7*; brownwater: *Variant V2b*; greywater: *Variant V5*)

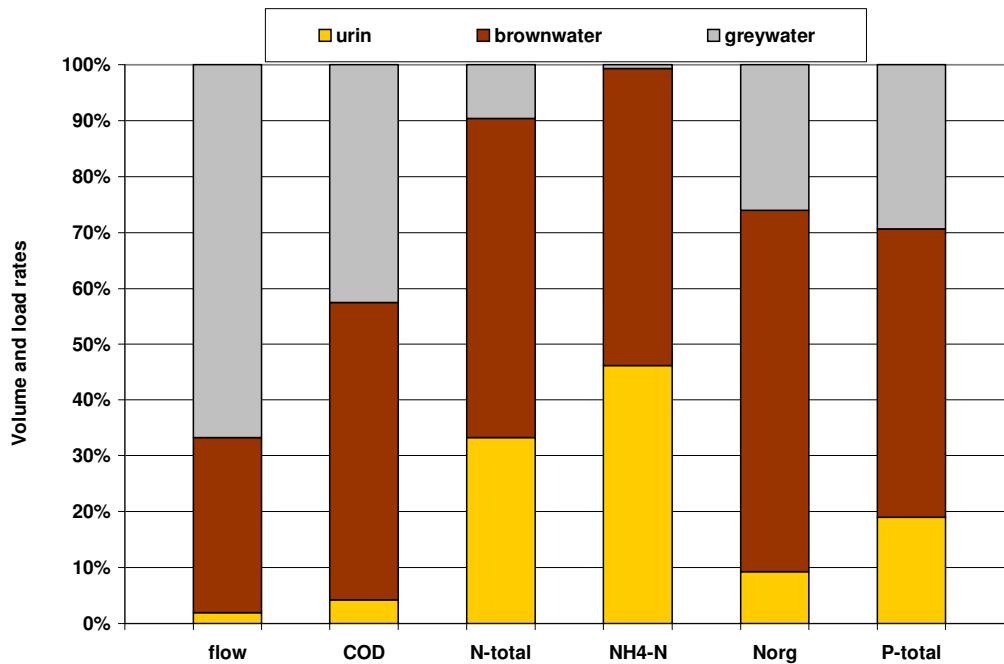
**Fig. 3.6.2:** Volume and mass balances of different parameters of yellow-, brown- and greywater from the apartment house (data basis: yellowwater: *Variant V6b*; brownwater: *Variant V7*; greywater: *Variant V7*)

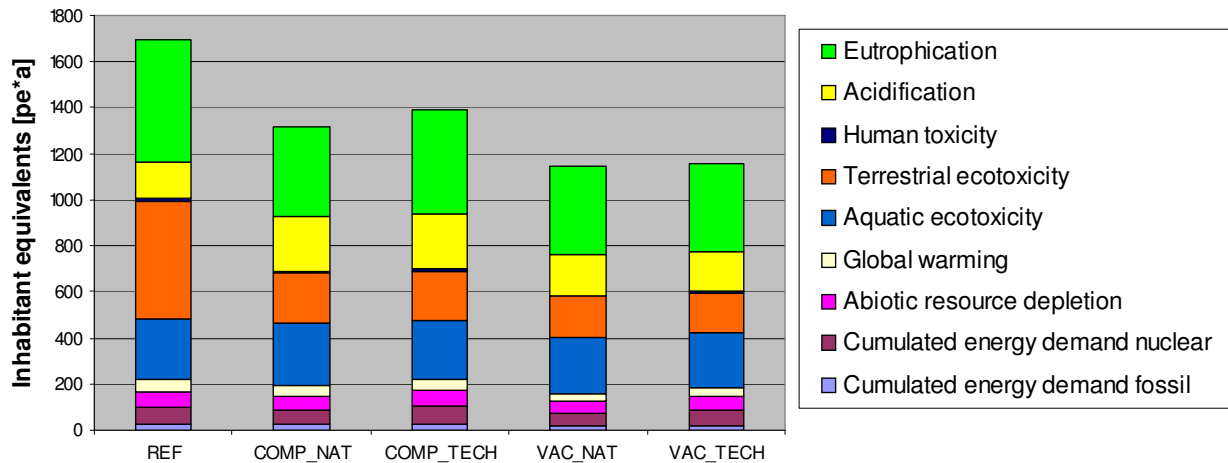
**Fig. 4.1:** Normalised eco-profiles as inhabitant equivalents (environmental impact) of conventional system (Ref) and different configurations for alternative sanitation systems (Comp/Vac: faeces composting/digestion, Nat/Tech: Greywater treatment with soil filter/SBR)
